# NATIONAL ADVISORY COMMITTEE FOR AERONAUTICS

TECHNICAL NOTE 4132

FATIGUE INVESTIGATION OF FULL-SCALE  
TRANSPORT-AIRPLANE WINGS

VARIABLE-AMPLITUDE TESTS WITH  
A GUST-LOADS SPECTRUM

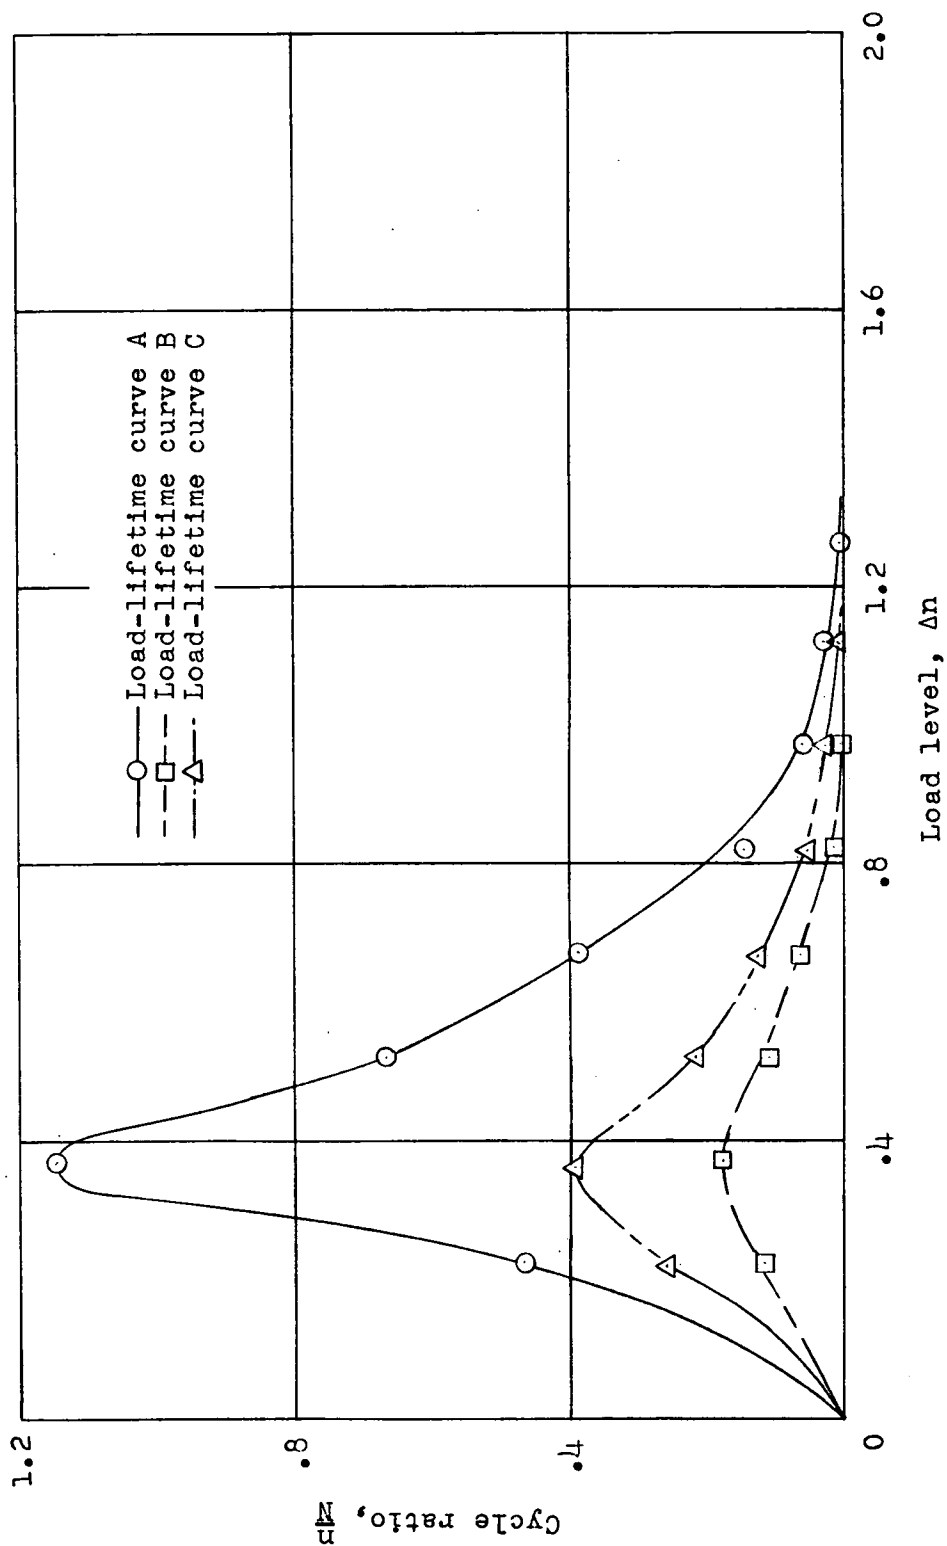
Figure 14.- Cycle ratios for crack 17, based on curves of figure 13.

In figure 14 the cycle ratio  $\frac{n}{N}$  is plotted against the load level of the spectrum for a typical crack. The figure shows that the highest loads were applied so infrequently that their cycle ratios were negligible compared with the cycle ratios for the lower load levels. The periodic application of these high loads may have had the same effect as the periodic high loading reported in reference 6. This same effect may account for the higher spread in the variable-amplitude lifetimes than in constant-amplitude lifetimes.

A closer examination of figure 14 shows that, according to the linear-cumulative-damage theory, most of the damage was caused by loads between about 0.3g and 0.45g, as indicated by the high, sharp peak. This concentration of damage in a narrow band has generally led to the assumption that other load levels have very little effect on the damage, and thus the damage could be assessed with very little error by considering one small range of loads. Further simplification would result in a constant-amplitude test at a low load level. This report shows that the theory of linear cumulative damage results in an underestimated life. Further, as outlined in the section entitled "Results," a constant-amplitude test at this low load level may not reveal the locations of all the cracks, particularly the ones that propagate and ultimately cause failure of the wing.
